**Shoreline Erosion Control Project**  
**Funded by EPA NPS319 and US Fish and Wildlife Service Partners Project**  
**2013-2015**

**Objective:**

Correct erosion problems that have occurred on the East end of the marina through replanting of the area with native plants, and anchoring soil down through willow bundles.

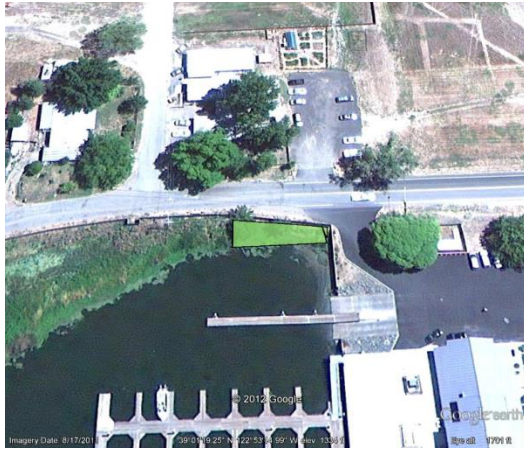
Figure 2: Area of Erosion Control Project  
(85 ft x 25 ft)

EPA staff met twice with staff of the local Natural Resource Conservation Service (NRCS): Korinn Woodard and Kate O'Donnell of Lakeport NRCS and Jack Alderson of Colusa NRCS. On February 24, 2012, Korinn and Jack joined Sarah Ryan and John Gichuki to look at the extent of the erosion problem in the marina (See Figure 2). Their suggestion was to anchor down willow bundles (using willow branches from the berm) along the mid eroded area of the shoreline (see Figure 3), to break the impact of the waves, to hold soils that run down and to provide a location for saplings to be inserted in the spring.

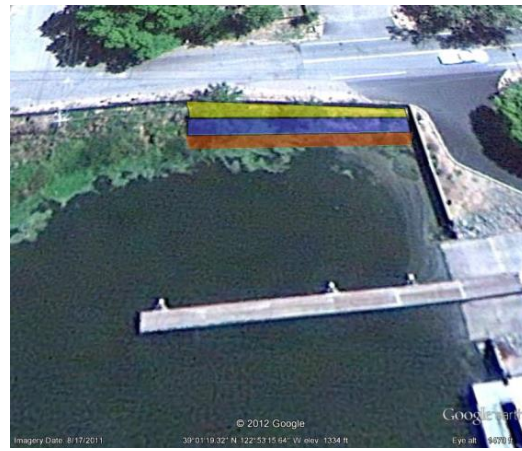
Figure 3:  
Red – tule replanting 85 ft x 3 ft  
Blue – willow bundles 85 ft x 14 ft  
Yellow – Native plants 85 ft x 8 ft

Jack again joined us, along with Kate O'Donnell, on October 11, 2012, to further develop the project idea. With the lake levels low, we have the opportunity to revegetate the lower eroded area of the shoreline (see Figure 3) with tule plugs from offsite. Earlier tule replanting along the shoreline (conducted in 2010), resulted in successful regrowth of tules. We did a site visit to the berm and found that many willows were the right size for the project (over 6 feet tall and an inch in diameter).

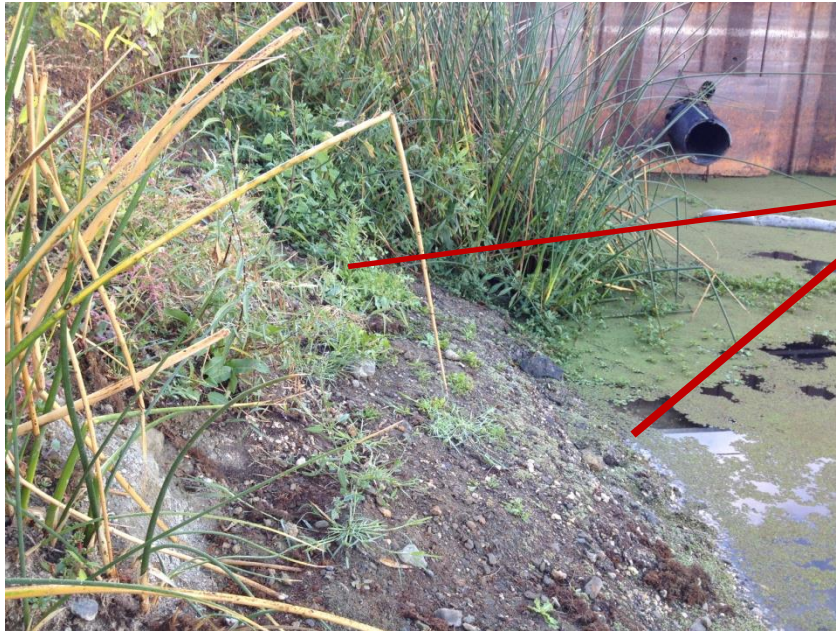
### TULE (LOWER LEVEL)

Tule planting range 3-4 feet above water line to lake level. Tules should be planted 18 inches on the center. Tule replanting video must be watched first:

1. Removing tules with tubers at various locations around the lake using county YouTube tule replanting videos for training labor
2. Planting tules with tubers on shoreline 18 inches apart on the center

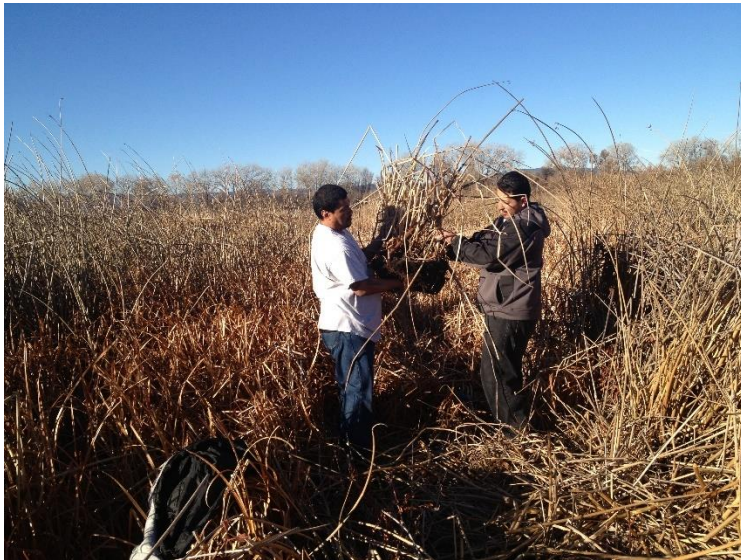
Harvesting native tule plugs at a source area

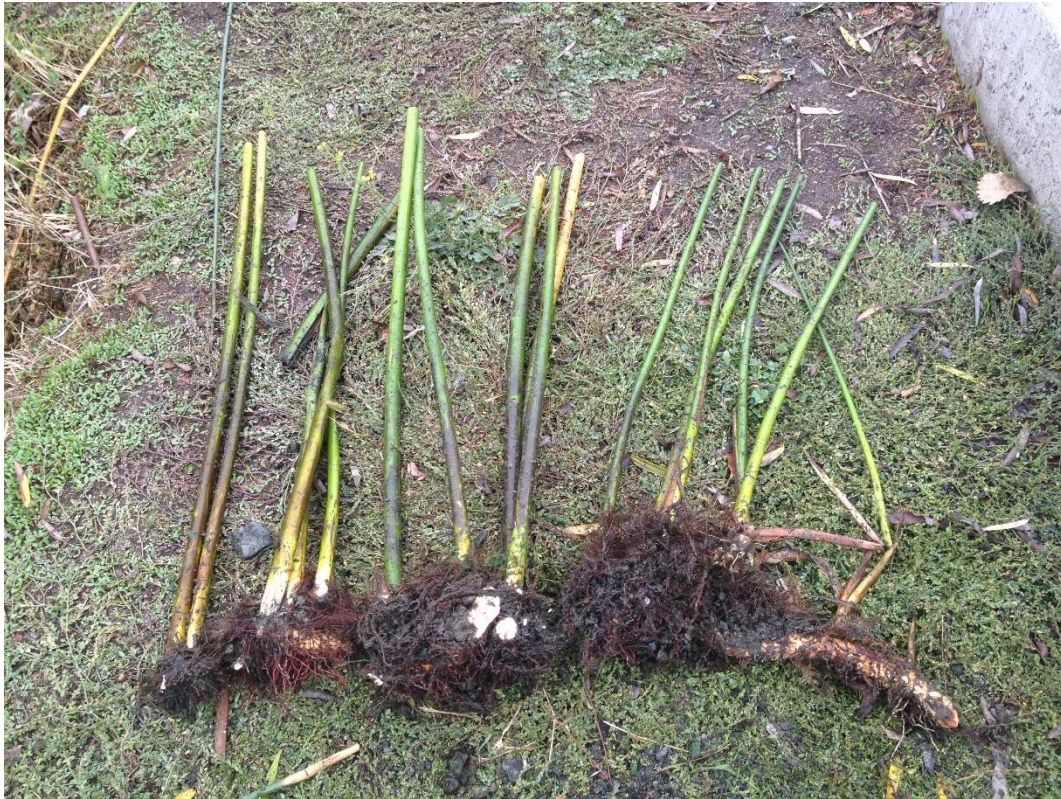
**Prepping tule plugs**

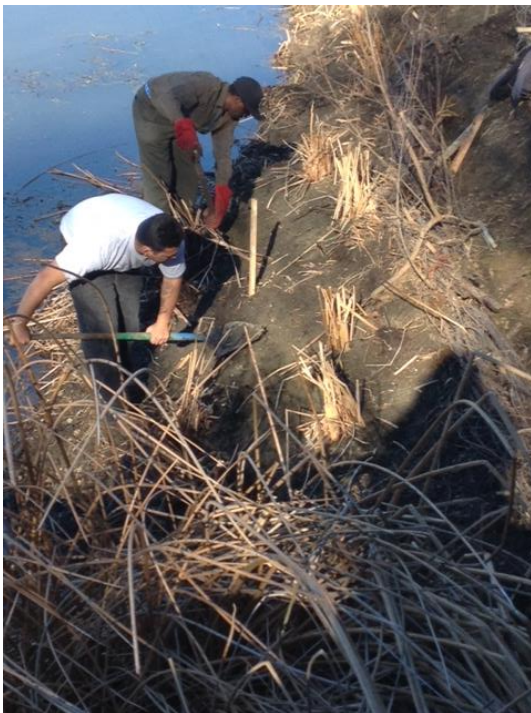
**Installing tule plugs at project site**

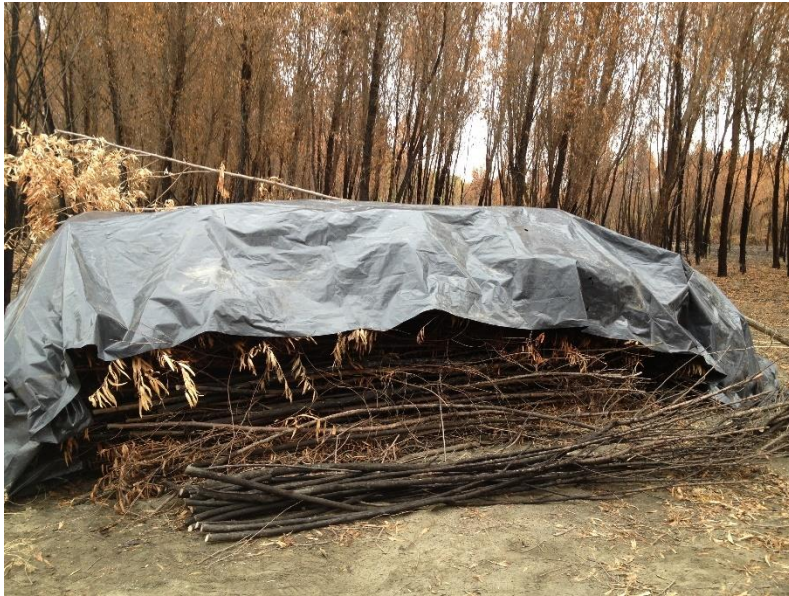
**Harvesting willow for bundles. Willow is cut and stored for months to dry, ensuring no live sprouting, a requirement due to cultural considerations**

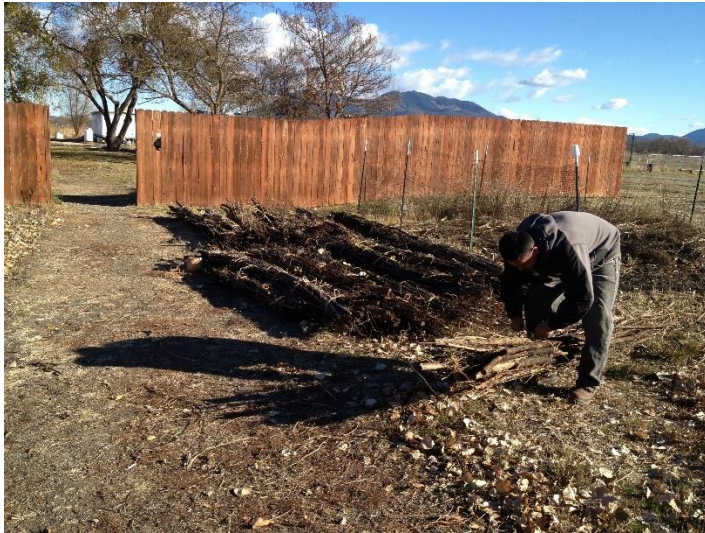
**Making willow bundles**

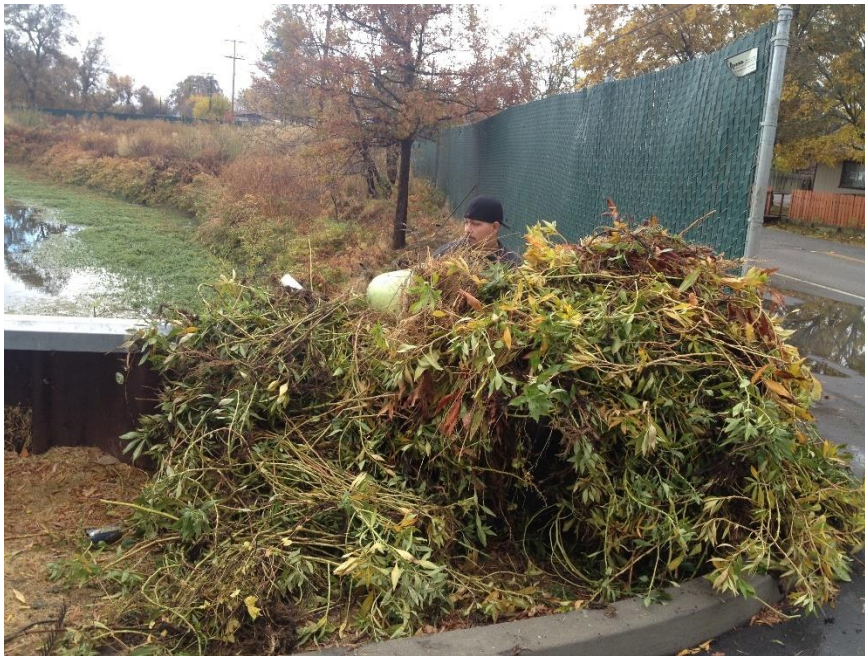
**Prepping project area, removing invasive aquatics near shoreline**

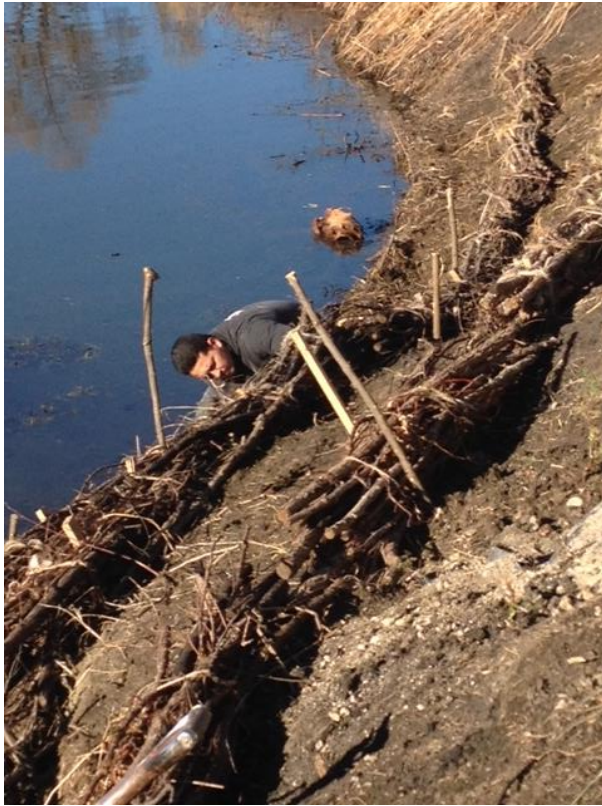
**Installing Willow bundles and local native dogwood stakes**

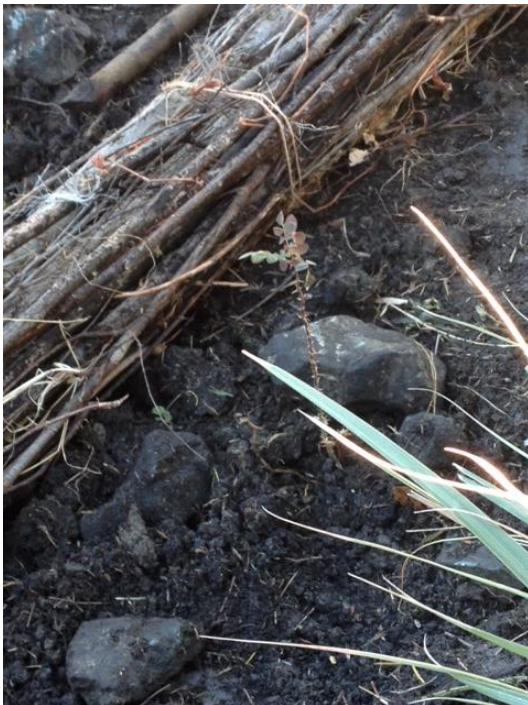
**Wild rose planted in top level**

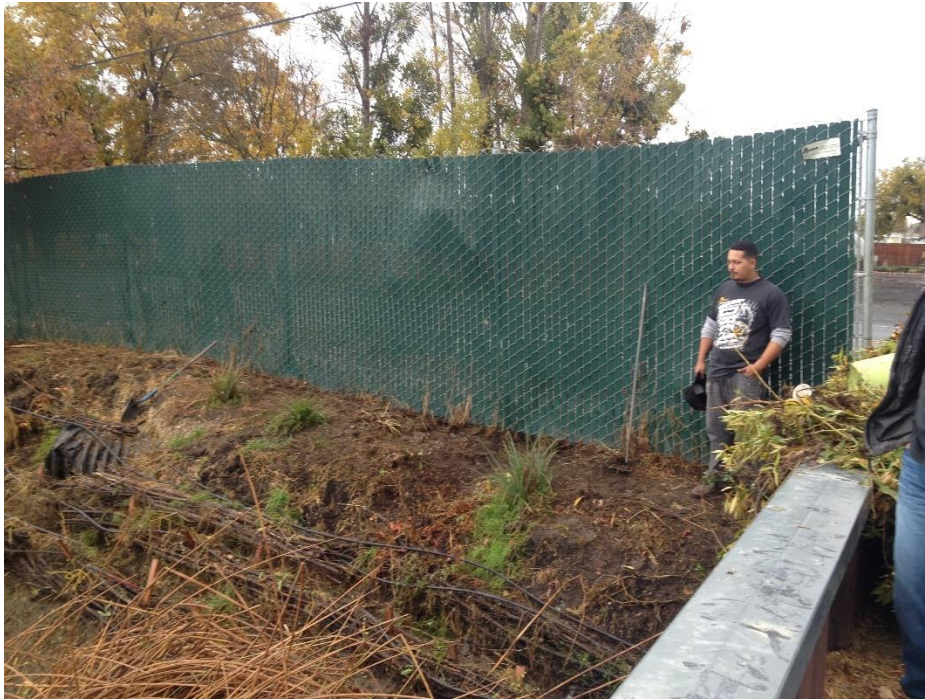
**Sedges installed**

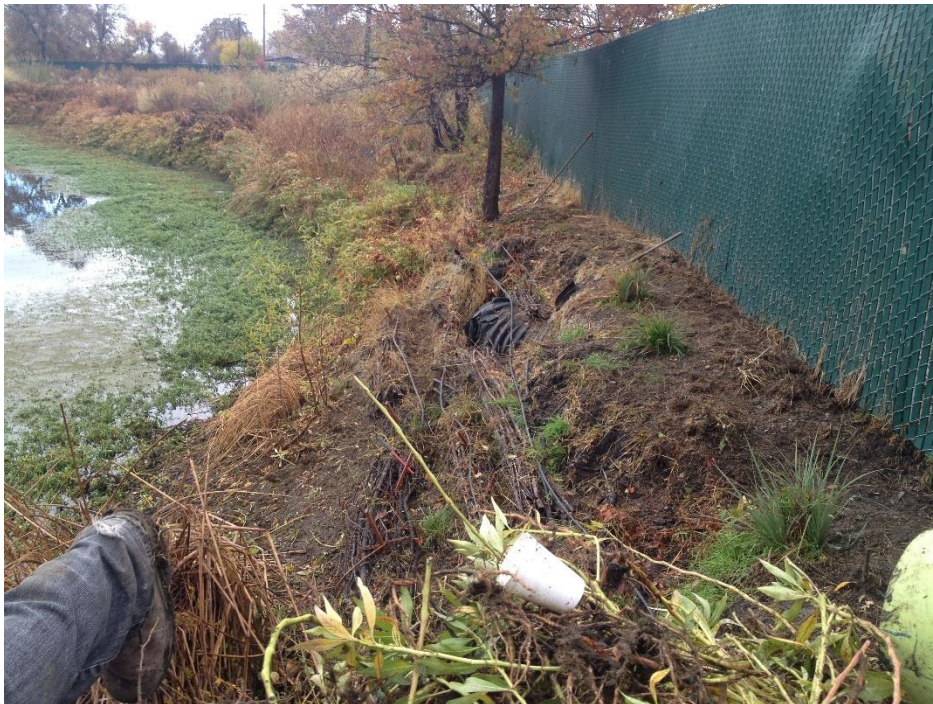
**Installing irrigation**

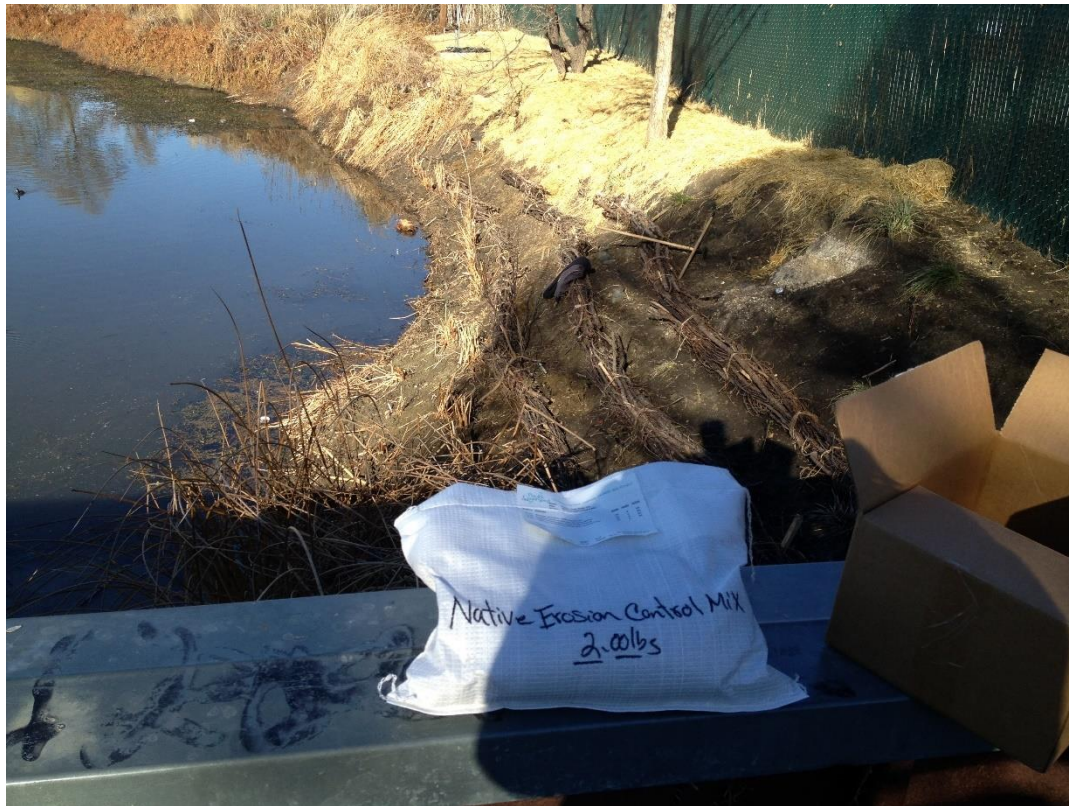
**Native Erosion control Mix for project area**

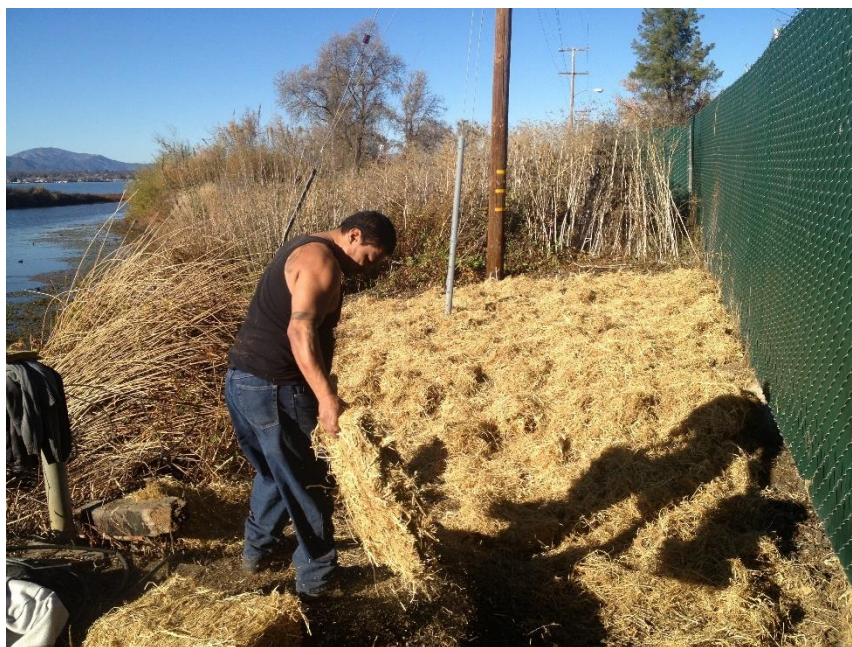
**Installing straw over project area after all plantings**

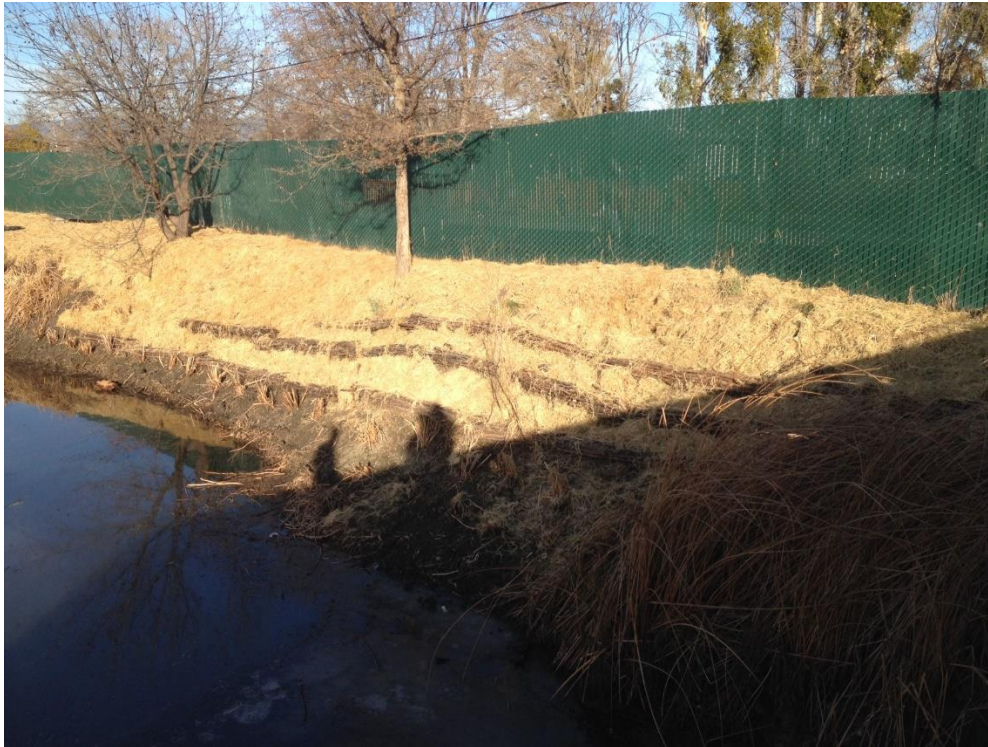
**Project Area replanted and seeded with native erosion control mix and covered with straw**

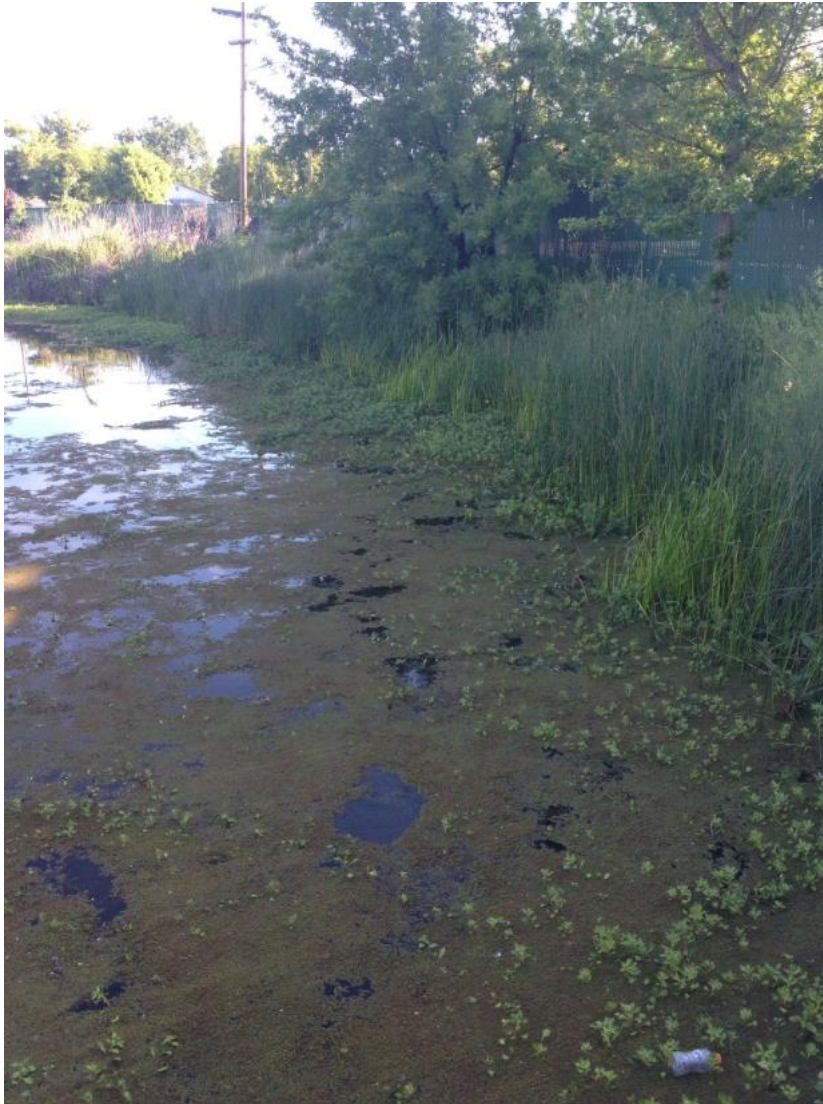
**Restored Marina shoreline BMP, installed willow bundles, native plants and erosion seed mix**

As of 2015, the project site has continued growth of installed native plants. Irrigation was removed 1 year after planting. Because of the continued drought, some plants were lost such as the wild rose. The tules appear to be prolific. Erosion off the site appears to be minimal.
