# ADOBE CREEK CHI HABITAT SUITABILITY ASSESSMENT

Prepared for the Big Valley Band of Pomo Indians

November 13, 2023

Authors: Bethany Hackenjos, P.E.;  
Anna Kladzyk Constantino; Cameron Tenner

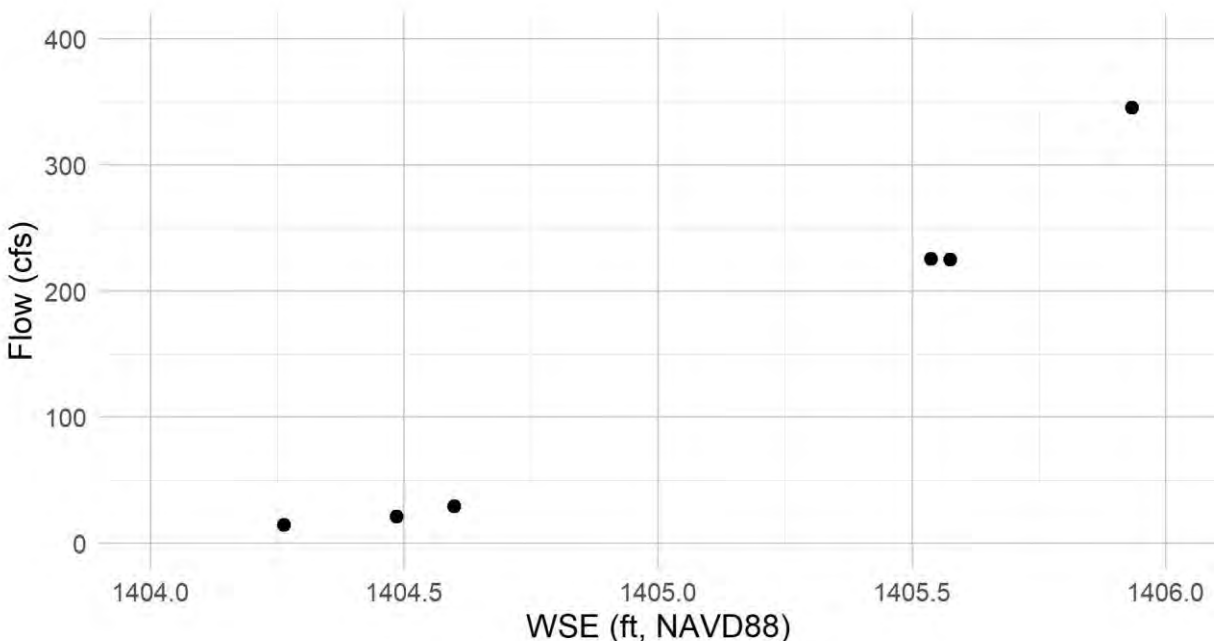
FIGURE 3 BELL HILL ROAD WSE VERSUS FLOW PLOT

FlowWest and BVR EPA have conducted four discharge measurements at the transducers since installation, on January 21<sup>st</sup> 2020, December 16<sup>th</sup> 2021, April 22<sup>nd</sup> 2022, and January 24<sup>th</sup> 2023. Preliminary data that will be used to build rating curves at the transducer locations are presented in Figure 3 through Figure 5. There are more flow measurement points at the Bell Hill Road site because during a high flow event in December 2021, conditions were unsafe to conduct measurements at the downstream sites. Regular maintenance and quality review of these data are important because of the mobility of channel bed material in Adobe Creek. In Figure 4, the plot of water surface elevation (WSE) in the creek versus flow at Argonaut Road shows flow measurements of both 12 cubic-feet per second (cfs) and 20 cfs result in approximately the same water surface elevation. This indicates a datum shift at this transducer and requires additional data collection to create a rating curve that can be used for flow estimation. The Bell Hill Road and Soda Bay Road flow measurement data were used to calibrate the 2-D model.

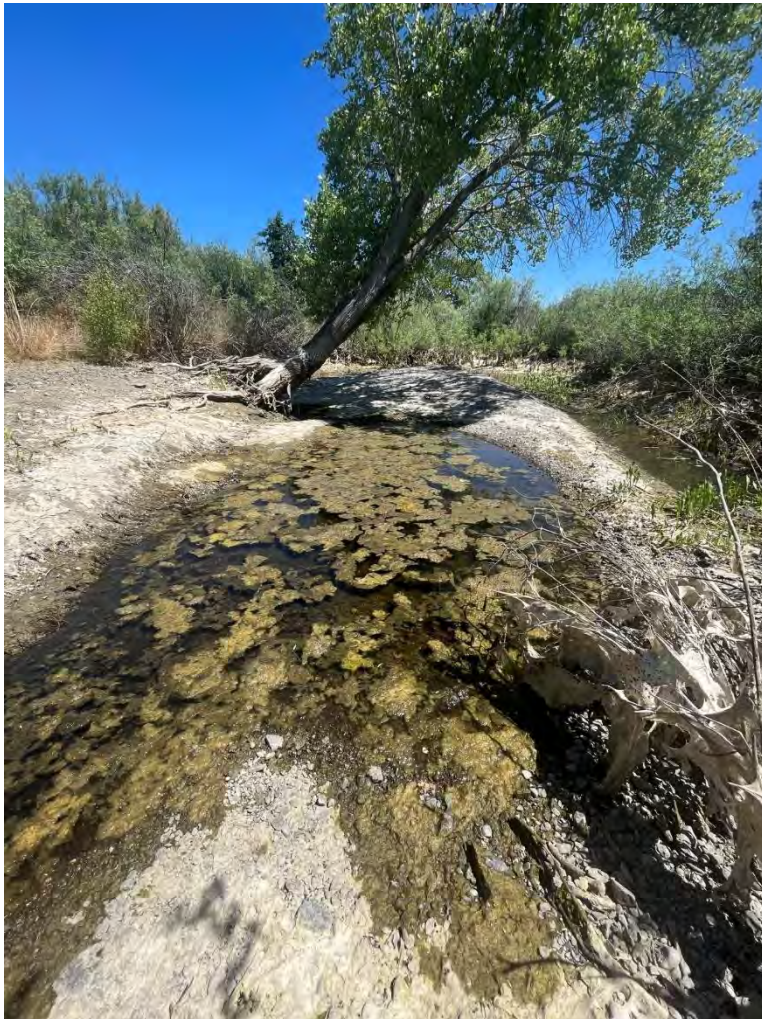
Model topography and channel bathymetry were developed for baseline creek conditions using a 3-foot resolution digital elevation model (DEM), developed from a June 15, 2022 lidar flight by GeoTerra. The lidar flight was conducted in June to reduce the likelihood of water in the Adobe Creek channel. Lidar does not penetrate water, so conducting the survey during dry conditions is important for using this terrain data to quantify instream habitat for chi, which often occurs in shallow depths of streamflow. During the flight, Adobe Creek was mostly dry, with the exception of two locations. The first location was downstream of Bell Hill Road, where two pools were observed by Big Valley EPA staff (Figure 8). The pools were described as a main pool approximately 7 feet wide with a 1.75 feet depth at its deepest, with a smaller pool wrapping around the outside of the main pool for 15 feet with approximately 3.5 feet of depth. BVR EPA field observations of the pool were reported to GeoTerra, who interpolated the terrain surface in this area to adjust for the pool. The second wetted area was caused by backwater from Clear Lake, and was observed only via aerial imagery. This wetted area extended upstream of the Adobe Creek mouth by approximately 2,500 feet, and was not corrected in the DEM.

FIGURE 8: SMALL POOLS PRESENT AT BELL HILL ROAD DURING JUNE 2022 LIDAR FLIGHT. PHOTO COURTESY ALIX TYLER AT BIG VALLEY EPA.

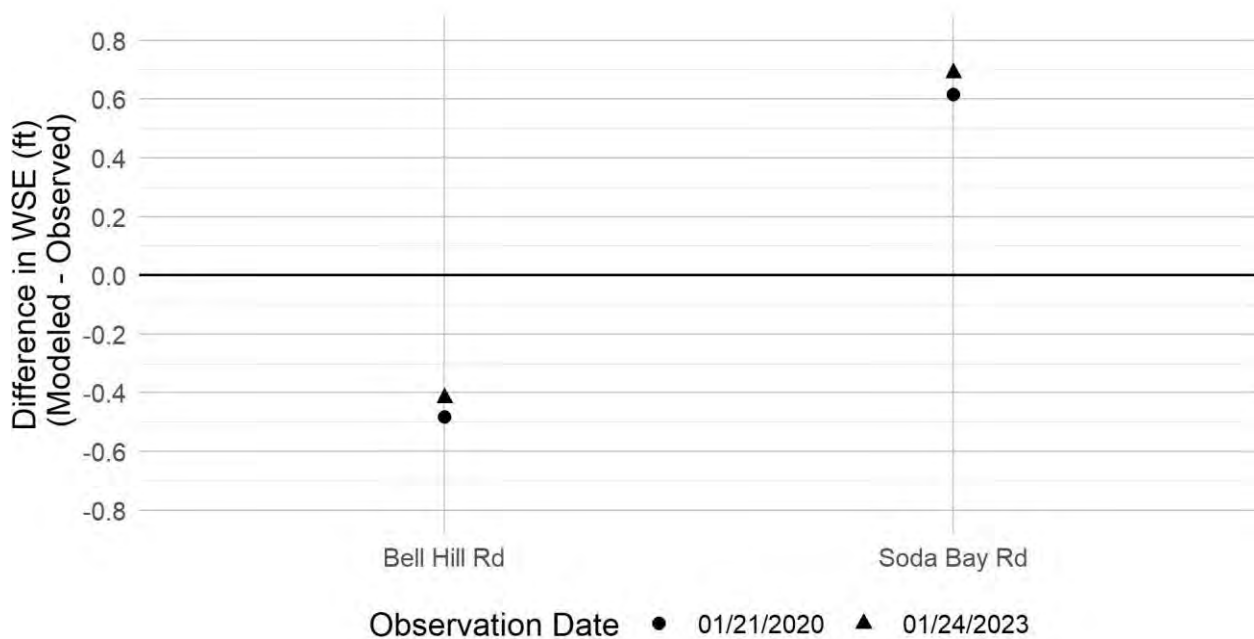
FIGURE 11: PRE-CALIBRATION MODEL ACCURACY AT TWO CALIBRATION FLOWS

Flows used for calibration were measurements from January 2020 and 2023. Differences between the uncalibrated model results and measured water surface elevations for both calibration runs are shown in Figure 11. Values greater than zero indicate the model results were higher than the surveyed values, and values less than zero indicate model results were lower than the surveyed values. These results indicate that the model is underestimating water surface elevations upstream at Bell Hill Road by a bit more than -0.4 ft, and overestimating water surface elevations downstream at Soda Bay Road by approximately +0.7 ft for the range of calibration flows.

Overall, such differences are considered reasonable and would not indicate much need for calibration given the uncertainty of the transducer equipment, data collection techniques, and accuracy of the 2-D hydrodynamic model simulation relative to real-world conditions. However, since the flows and water surface elevations of interest are low, these results represent a relatively large uncertainty when it comes to estimating aquatic habitat for the chi.

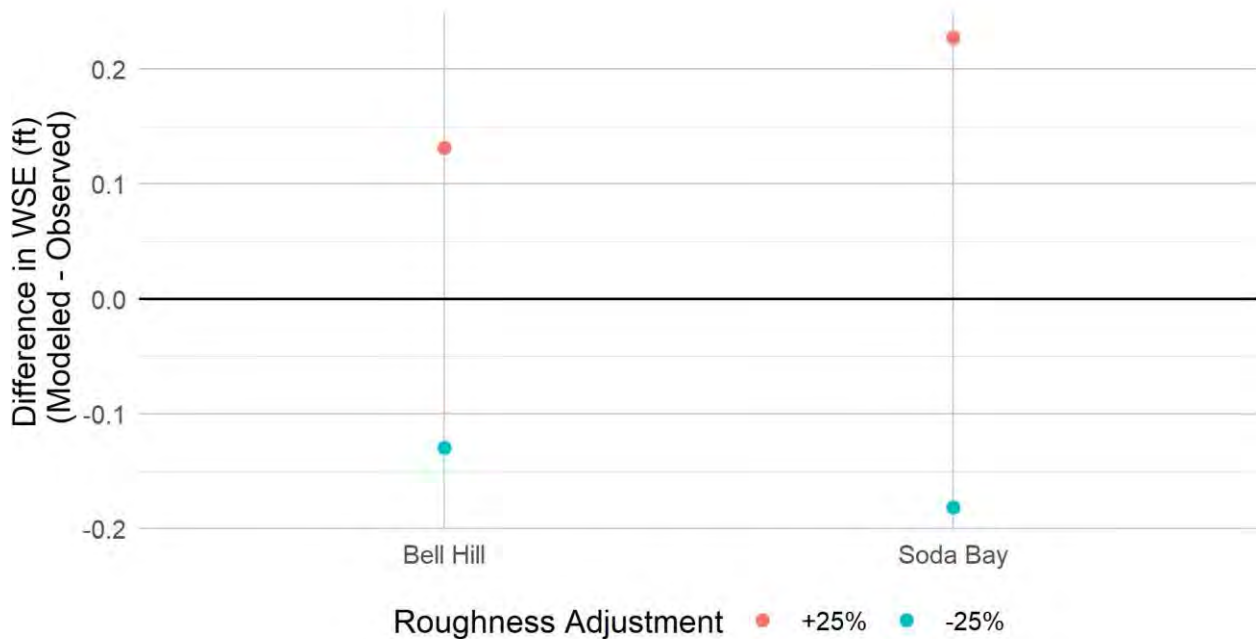
FIGURE 12: ROUGHNESS SENSITIVITY RESULTS

Considering this, we attempted to calibrate the model for better accuracy by adjusting the Manning’s roughness coefficients used in the model’s landcover layer. Figure 12 shows the results of a roughness sensitivity run performed during the calibration process. Details on this sensitivity run are provided in the Manning’s Roughness Coefficient subheading in the Model Sensitivity section. Figure 12 shows that at both calibration locations, water surface elevation responses to substantial roughness changes ( $\pm 25\%$ ) are fairly limited. Additionally, shifting the roughness values in one direction (increasing or decreasing) will improve accuracy at one calibration location but decrease accuracy at the other. Considering this, and further informed by in-field observations that instream conditions changed markedly upstream and downstream of Finley Road—with a rougher, less incised channel upstream and a smoother, more incised channel downstream—the base channel roughness value of 0.035 was increased to 0.04 upstream of Finley Road and decreased to 0.03 downstream of Finley Road. This has

the effect of slightly increasing accuracy at both calibration locations while reflecting field observations. The final calibrated model is underestimating water surface elevations upstream at Bell Hill Road by slightly less than -0.4 ft, and overestimating water surface elevations downstream at Soda Bay Road by slightly less than +0.7 ft at the calibration flows. Additional collection of flow and water surface elevation conducted by BVR EPA may help reduce uncertainty in subsequent stages of the model development for this system.

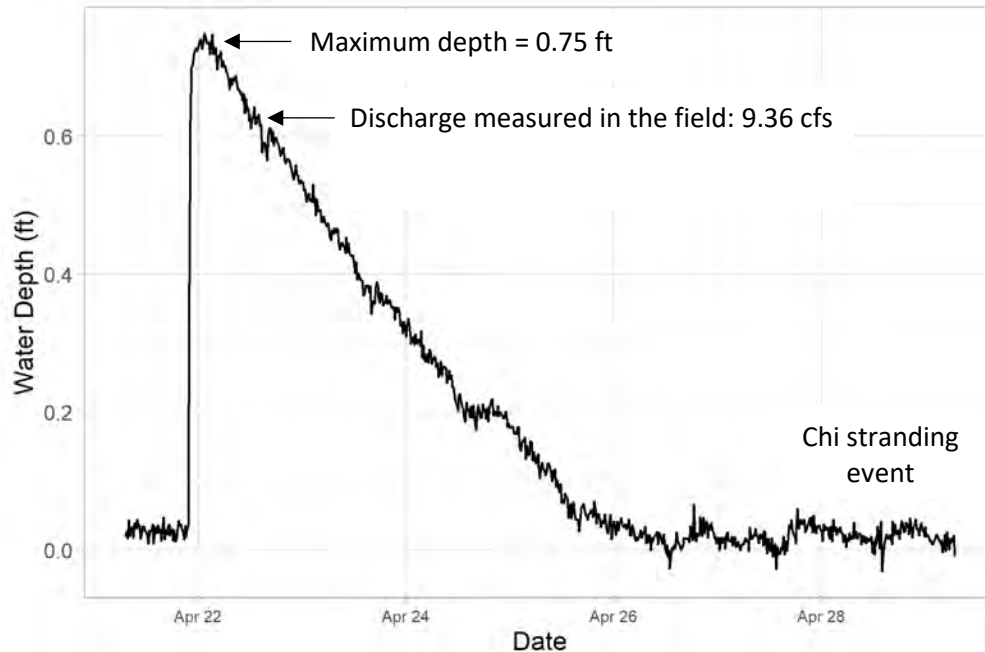
FIGURE 13: TRANSDUCER DATA AND FIELD MEASUREMENTS AT SODA BAY ROAD IN LATE APRIL 2022

Model results show unsuitable depth limitations upstream and downstream of Soda Bay Road at low flows, which are in agreement with observations during the 2022 spawning season. Figure 13 shows a time series of water depth from the transducer at Soda Bay Road spanning the period from 4/21/2022 to 4/29/2022. Between 4/11/2022 and 4/23/2022 the Adobe Creek area received approximately 1.8 inches of rain (averaged rainfall totals from the National Weather Service LAKEPORT 0.6 SE and KELSEYVILLE 2.8 NNE stations; NWS 2023). As shown in Figure 13, water depth at the Soda Bay Road

transducer peaked at 1:30 AM on 4/22/2022 with a depth of 0.75 ft. FlowWest manually measured the discharge just downstream of Soda Bay Road bridge at 3:30 pm on 4/22/2023 and found it to be 9.36 cfs. Flows and water depths continued to fall over subsequent days, and fish rescues were performed by CDFW and Tribal staff on 4/28/22. Depths measured by the transducer during the fish stranding event on 4/28/22 were between 0.0 ft and 0.05 ft.

Note: Depths values from the transducer that oscillate around 0.0 are associated with error from the equipment.

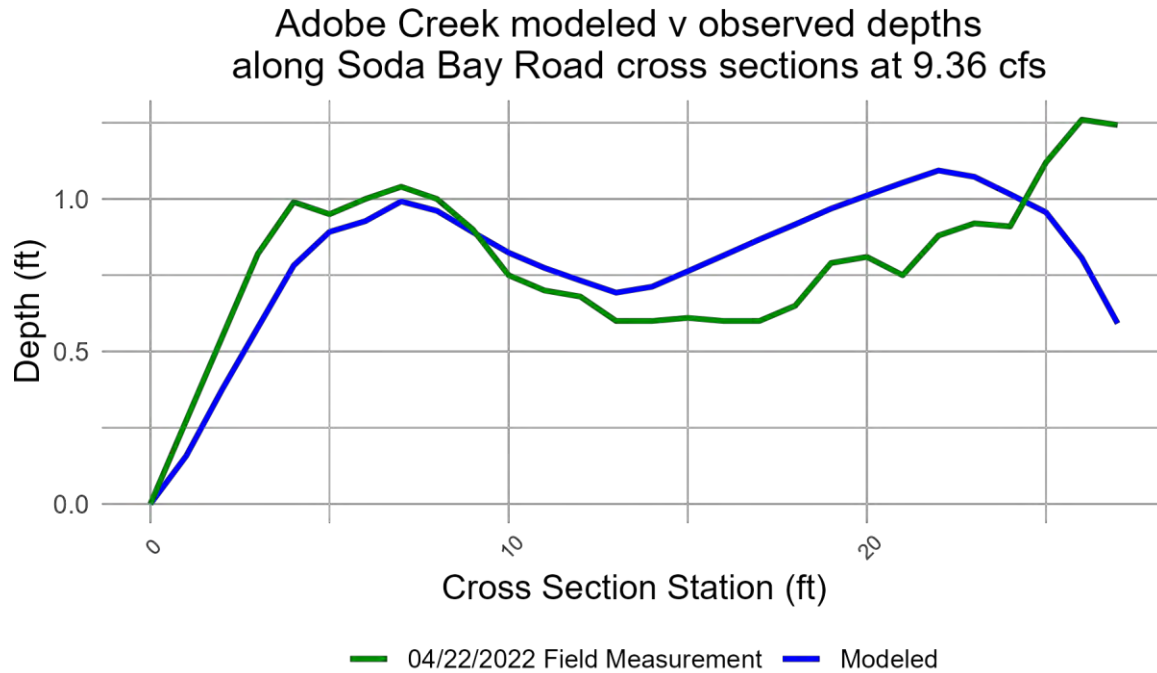
FIGURE 15: CROSS SECTIONAL DEPTH COMPARISON FOR MODEL VERIFICATION

When flow was measured on 4/22/2022, depth measurements were taken along a cross section just downstream of Soda Bay Road. These cross-sectional depth measurements, taken at 9.36 cfs, were compared to depth results on a representative cross section from a 9.36 cfs steady state model run. Figure 15 overlays the modeled and surveyed cross sections of water depth at 9.36 cfs. The cross sections are fairly similar, with maximum depths within 2.5 inches of each other and a qualitatively similar cross sectional depth pattern (depth decrease in the center of the channel with peaks on either side). These two verification analyses suggest that the model is adequately representing low flow conditions in Adobe Creek, and can be used to estimate chi habitat suitability.

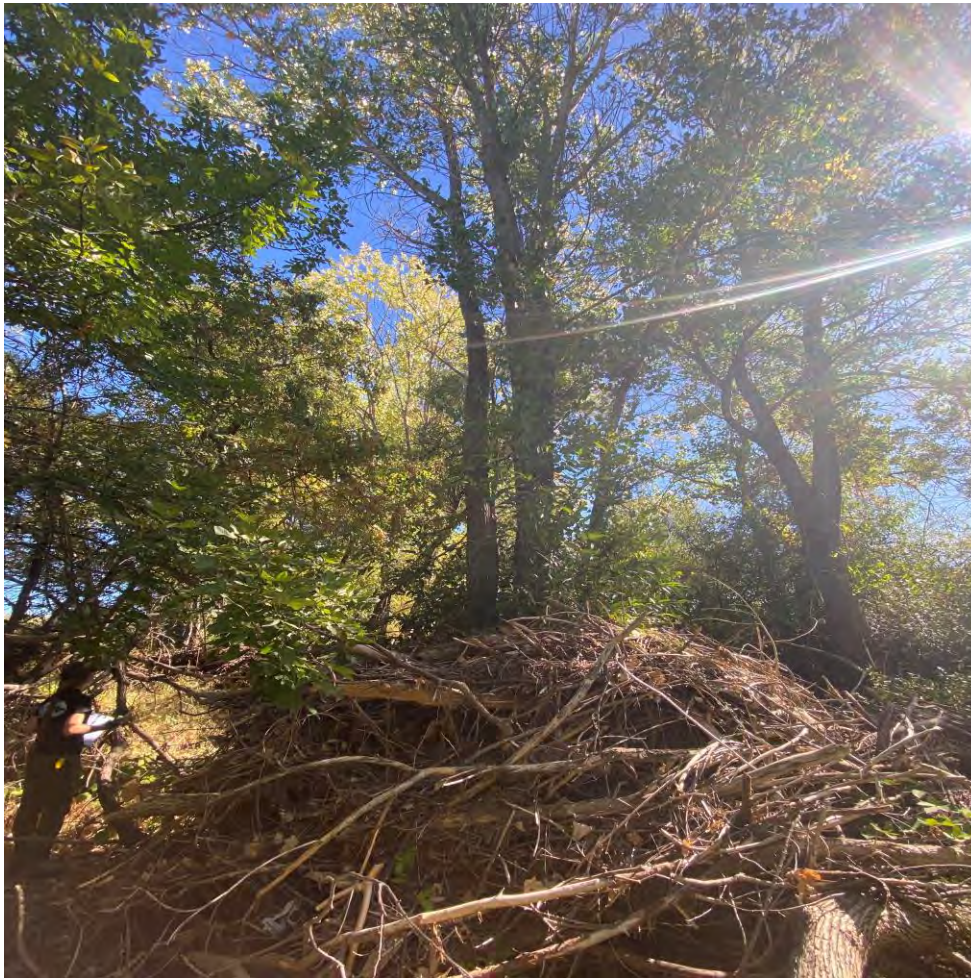
FIGURE 23: WOODY DEBRIS FOUND AT 34 CFS VELOCITY DISCONNECTION

As previously mentioned, the velocity limitation at 34 cfs located upstream of Soda Bay Road was investigated during a site visit (see Appendix A for additional information and photos). We found the channel in this area to be significantly overgrown with willows and accumulated woody debris. Figure 23 shows the woody debris that has accumulated around a large willow growing in the center of the channel. Figure 24 shows the current low flow path through this overgrown area, which is very narrow and incised and overlain with woody debris. Field observation of this site contextualizes and nuances the disconnection shown in the model. There could be a high-velocity-caused disconnection here due to the narrowed and incised bypass pictured in Figure 24. However, there could also be bathymetry inaccuracies in this region (caused by woody debris obstructing lidar) that indicate a false velocity limitation for chi. This illustrates the importance of field observation to supplement and contextualize model results. If time and funding allowed, this area would be a great candidate for a bed elevation survey to improve future modeling efforts. Additionally, other disconnections identified in the modeling effort would be better understood through field observation.
